[Docket No. 2002-NE-08-AD; Amendment 39-12865; AD 2002-16-26]

Airworthiness Directives; Bombardier-Rotax GmbH Type 912 F and 914 F Series Reciprocating Engines; Correction

Airworthiness Directives; Bombardier-Rotax GmbH Type 912 F and 914 F Series Reciprocating Engines

2002-16-26 Bombardier-Rotax GmbH: Amendment 39-12865. Docket No. 2002-NE-08-AD.

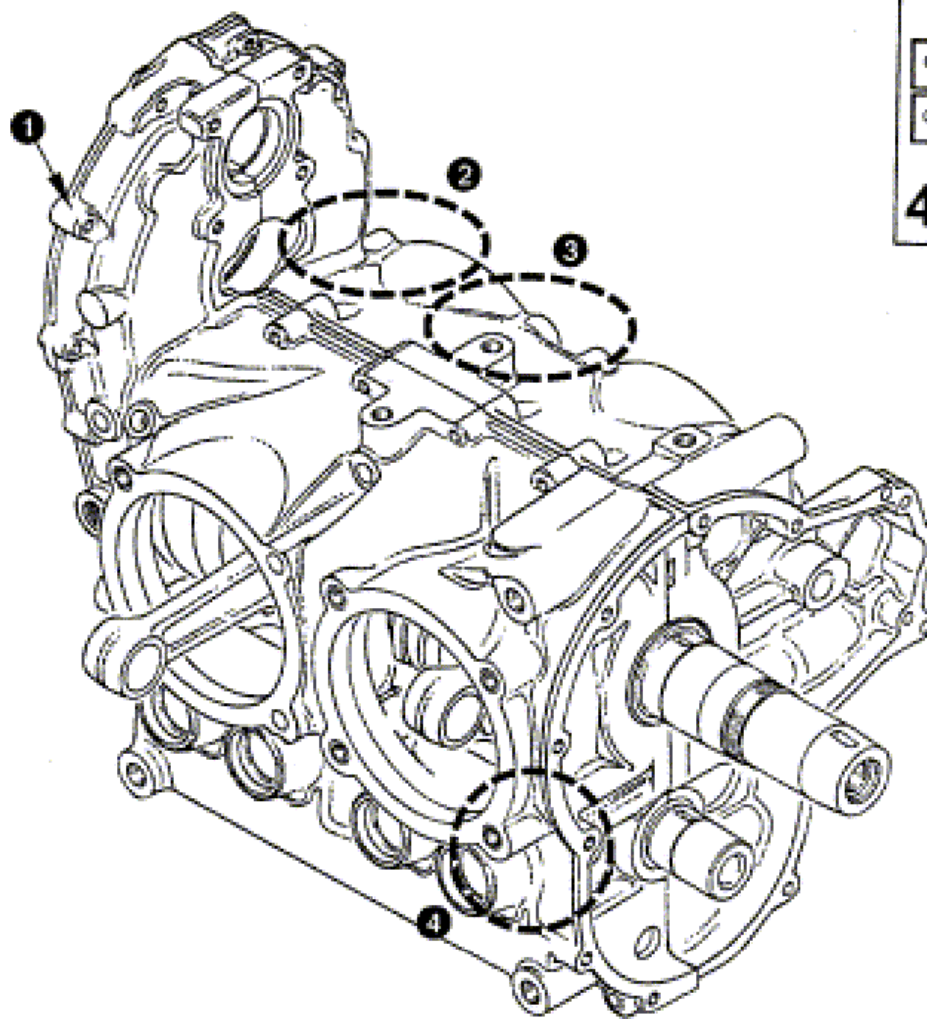
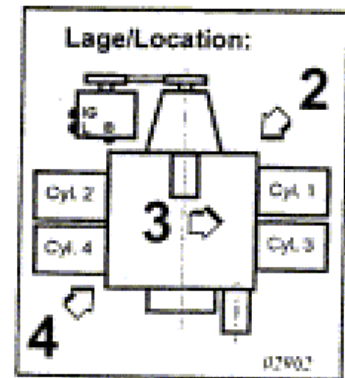
Figure 1. Engine Crankcase Inspection Areas

(1) Inspect the engine crankcase (item 1, Figure 1 of this AD) for cracks especially in the area of cylinder 1 upper side (item 2), between cylinder 1 and 3 upper side (item 3), and cylinder 4 lower side (item 4).

1. Engine Crankcase
2. Cylinder 1 Upper Side
3. Cylinder 3 Upper Side
4. Cylinder 4 Lower Side

(2) Cracks in crankcases of engines with a ROTAX cooling air baffle may not be easily visible, and oil leaks may be an indication of cracks. Visually inspect for oil leaks in areas of (item 2) and (item 3).

(3) If oil leaks are found, determine the source by either using a borescope or removing the object blocking the view such as the air baffle or accessory, and perform the inspection.

(4) If the engine crankcase is cracked, replace engine before further flight. Repair oil leaks from any other cause.

(b) Visually inspect the engine crankcase (item 1, Figure 1 of this AD) for cracks at each 100-hour, annual, or progressive inspection, or within 110 hours TIS since last inspection, whichever occurs first, in accordance with paragraph (a) of this AD.
